# 7.3 Publikation III: Monitoring the "material climate" of wood to predict the potential for decay: Results from in-situ measurements on buildings.

Building and Environment. 2007, doi:10.1016/j.buildenv.2007.10.001

## By Christian Brischke<sup>a,\*</sup>, Andreas Otto Rapp<sup>a</sup>, Rolf Bayerbach<sup>b</sup>, Niels Morsing<sup>c</sup>, Peder Fynholm<sup>c</sup>, and Christian Robert Welzbacher<sup>a</sup>

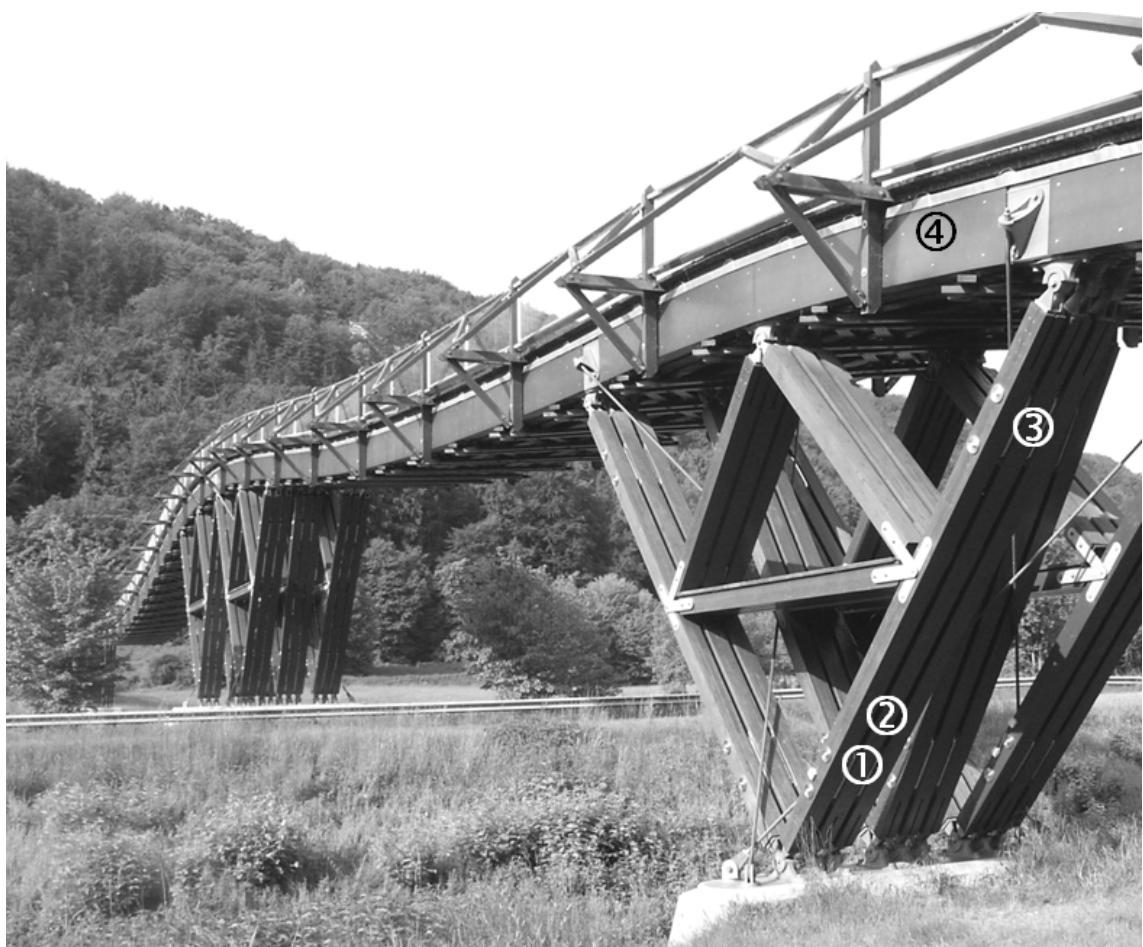
Figure 7.3-3. Self-supporting pedestrian timber bridge in Essing, made from Norway spruce gluelam: ① Bottom nail plates, ② region above bottom nail plates for installation of measuring points remote from the nail plates, ③ upper nail plates, ④ main trusses covered with plywood.

In total, 64 wooden substitute dowels were installed on the Essing bridge in May 2004. The measurement points were selected with respect to differences between weather side and non-weather side, and to the influence of nail plates in different heights of the construction (Figure 7.3-3, marks ①, ②, and ③). These plates act as a connection between single gluelam beams in the piers of the bridge. In addition, dowels were installed in the main trusses of the bridge, where firstly decay was observed in 1997, but which were afterwards protected

from rain water by plywood covers (Figure 7.3-3, mark ④). Here, the efficacy of this protective measure should be verified.

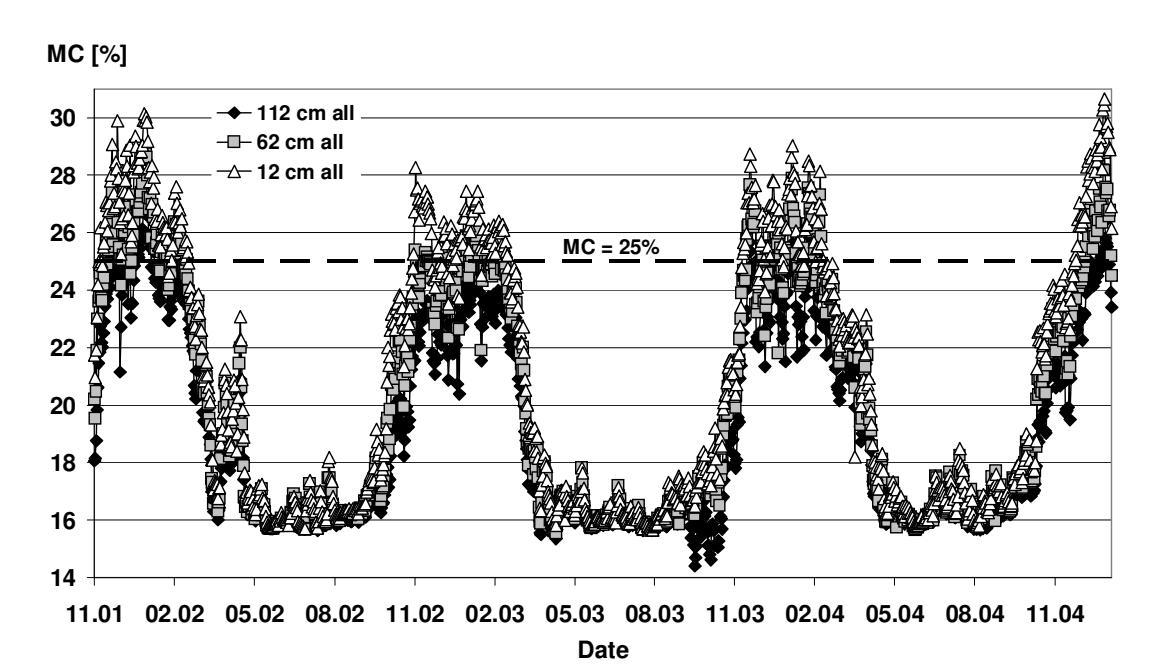
The system applied for measuring the MC within different parts of the cladding provided plausible values over the whole period of examination (Figure 7.3-5). The MC ranged between 15 and 30% over the year. MCs above 25%, which can become critical for the onset of fungal decay [13], were found between November and March. However, the risk of fungal decay during those months was limited, because of coinciding low temperatures.

Figure 7.3-5. Moisture course in boards of the upper facade for different roof overhangs.

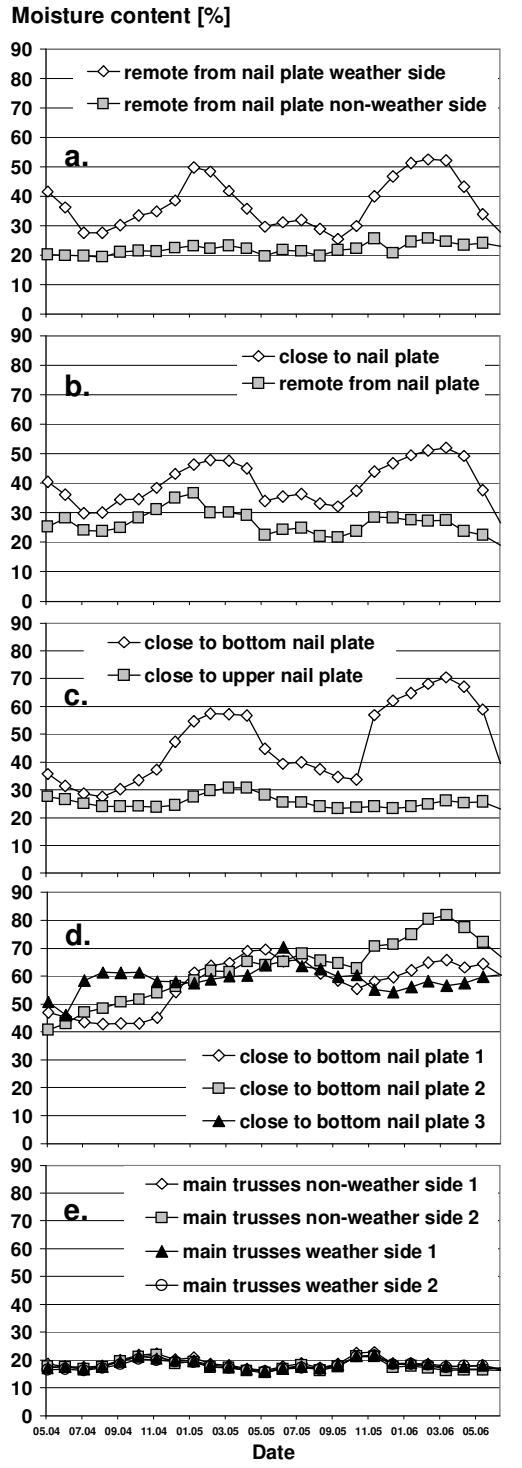
- Higher MCs were found on the weather side of the bridge compared to the non-weather side at all times. This is shown in Figure 7.3-6a for two measurement sites on the same pier. On the weather side the MC increased up to 50% during winter, whereas the MC on the non-weather side stayed below 30%.

- The MC close to the bottom nail plates was significantly higher as remote from (directly above) the plates for most of the examined piers (Figure 7.3-6b). This coincides with severe decay in eight different beams, which was unexceptionally found close to bottom nail plates.

- The risk of moisture accumulation close to the upper nail plates was found to be significantly lower compared to the bottom nail plates (Figure 7.3-6c). However, the MC close to some upper nail plates on the weather side was equal to that close to the corresponding bottom nail plates, but never higher.

- The MC in areas with decay (here: brown rot decay) was drastically increased, and as decay was found only behind nail plates, the wood did not dry out again (Figure 7.3-6d).

- The plywood sheets, which cover the main trusses of the bridge, were found to be an effective protective measure; the MC in the trusses never exceeded 25% (Figure 7.3-6e).
- Differences in relative humidity and air temperature between different parts of the bridge (close to/ apart from the water) were negligibly small.

Figure 7.3-6. Examples of monthly mean moisture content courses in comparison between selected distinctive building components of the Essing bridge. (a) Course of MC in piers on the weather and the non-weather side, remote from nail plates, (b) Course of MC in a pier close to and remote from a nail plate, (c) Course of MC close to a bottom and an upper nail plate, (d) Courses of MC in three piers of the weather side close to bottom nail plates, already showing decay, (e) Courses of MC for four measuring points on the plywood covered main trusses on the weather and the non-weather and the non-weather side.

Secondly, the moisture courses from the Essing bridge partly revealed extremely different decay potentials between the building components, such as between weather and non-weather side. It was clearly shown, that the bridge is insufficiently protected by design in general. The nail plates, especially at the bottom part of the construction, were figured out as weak points in detail.
