## Performance of wood in the Franja partisan hospital

Davor Kržišnik, Christian Brischke, Boštjan Lesar, Nejc Thaler & Miha Humar

To cite this article: Davor Kržišnik, Christian Brischke, Boštjan Lesar, Nejc Thaler & Miha Humar (2018): Performance of wood in the Franja partisan hospital, Wood Material Science & Engineering

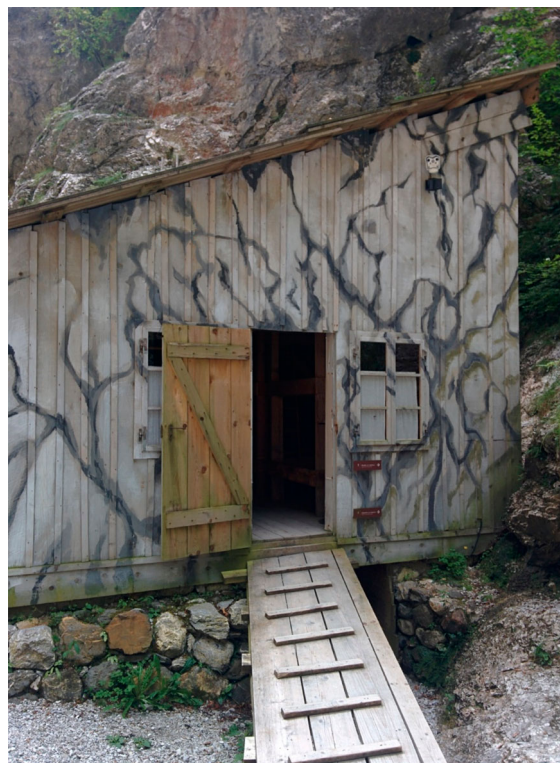
**Figure 1.** Cabin for the wounded at the WWII partisan hospital franja. Measurements were performed in the cellar (bunker) below the cabin, on the façade facing the hill, and on the first floor.

Monitoring was performed at the WWII partisan hospital Franja, Slovenia, which consists of 14 wooden barracks. Detailed monitoring was performed in the so-called cabin for the wounded at this hospital (<http://www.muzej-idrija-cerkno.si>) (Figure 1). The hospital is situated in a remote location in Pasice gorge near Cerkno (GPS location; 46.154081, 14.028197), approximately 600 m above sea level. Since the stream in the gorge is present during all seasons, the relative humidity is always very high. The majority of the huts were completely renovated in 2010 after a disastrous flood in September 2007. The design of the hospital is the same as it was during WWII. All huts were designed as temporary shelters, and subsequently declared a cultural monument of national importance. The cabins are made primarily of Norway spruce (*Picea abies*). Since the climatic conditions in the gorge are fairly harsh, all the Norway spruce wood was dip treated with a copper-ethanolamine-based wood preservative (Cu-EA) (Silvanolin®, Silvaproduct, Ljubljana, Slovenia). This product consists of copper

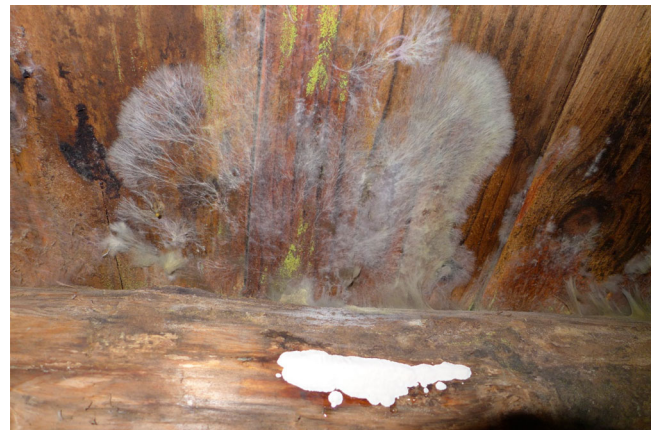
Figure 3. Mycelia of *Antrodia* sp. growing on the surface of wood in the cellar.

4000 ppm (Humar *et al.* 2016). Insufficient copper retention enables the growth of copper tolerant fungi such as *Antrrodia* (Schmidt and Moreth 1996; Humar *et al.* 2002), as well as other decay fungi.
