Environmental response of a CLT floor panel: Lessons for moisture management and monitoring of mass timber buildings

Evan L. Schmidt^a, Mariapaola Riggio^{a,*}, Andre R. Barbosa^b, Ignace Mugabo^{a,b}

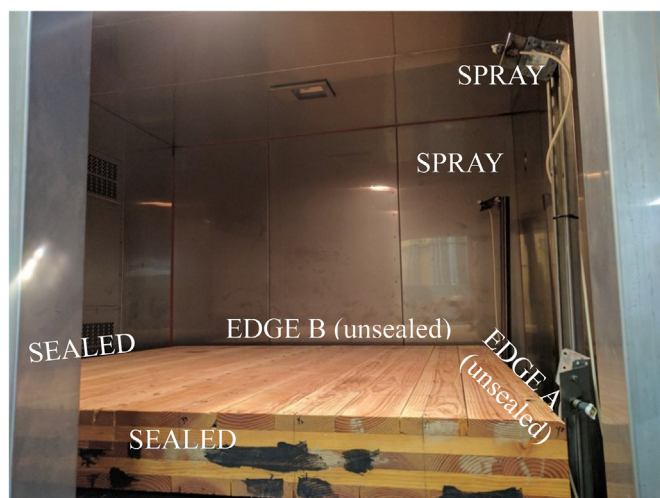
Fig. 1. The DF CLT panel installed in the environmental chamber.

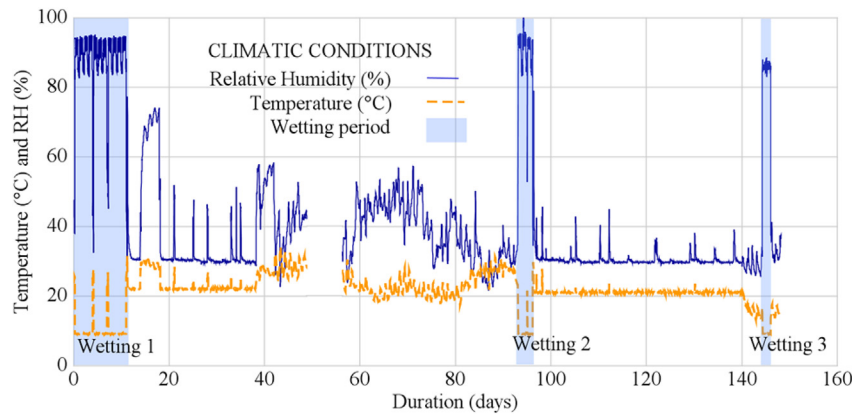
Fig. 3. Climatic conditions during testing.

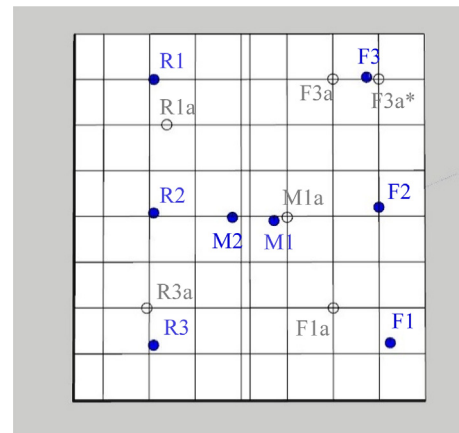
Fig. 5. A depiction of the locations of discontinuous moisture measurements. Empty circles are original locations, dark circles are adjusted locations. Each square on the grid is approximately 27 cm wide and long.

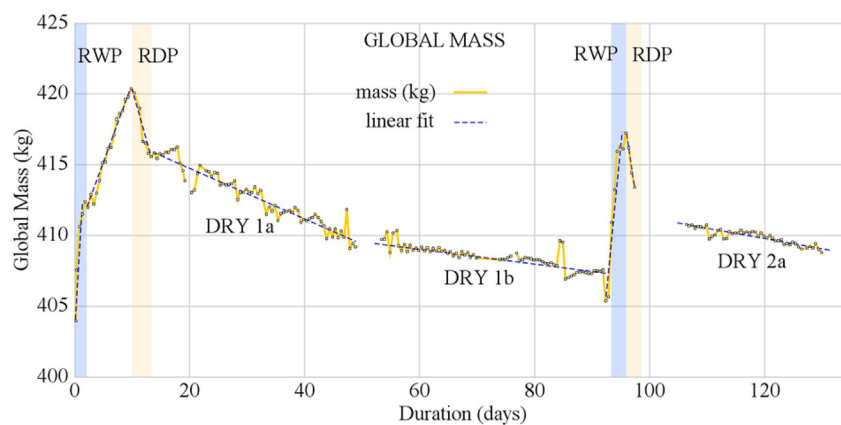
Fig. 7. Global mass of CLT sample plotted on a 12 h basis. RWP = rapid wetting period (blue shading). RDP = rapid drying period (yellow shading). (For interpretation of the references to colour in this figure legend, the reader is referred to the Web version of this article.)

Fig. 7 shows the global moisture content (GMC) change (measured by mass) during the weathering cycles. A maximum GMC increase of approximately 4.5% (16.1 kg added water mass) can be observed after 11 days of wetting (cycle 1). This value became roughly 3.5% (12.6 kg over 11 days wetting) when excluding what we will refer to as the “rapid initial drying phase”—RDP—(approximately the first 2 days of drying, which removes surface water). The second wetting cycle showed similar levels of gain (when excluding RDP, 3 kg of retained gain over 3 days of wetting). These values assumed an average starting moisture content of 12% in the panel and a consequent panel dry weight of 360 kg. Note that a 2% change in assumed average starting MC has an impact of less than 0.1% on the GMC calculations (i.e., 4.5% and $3.5\% \pm 0.1\%$). These figures are particularly interesting, considering [20]—in which samples were wetted in a similar manner for 14 days—observed an increase in GMC of 13% (from an average of 12%–25%) in edge-sealed CLT samples. The lower amount of global absorption observed could be due to a combination of the slightly shorter duration of wetting, thickness of the samples, species dependent resistance to diffusion and capillarity via pit aspiration [4], or other environmental factors such as precipitation volume, distribution and drainage slope.

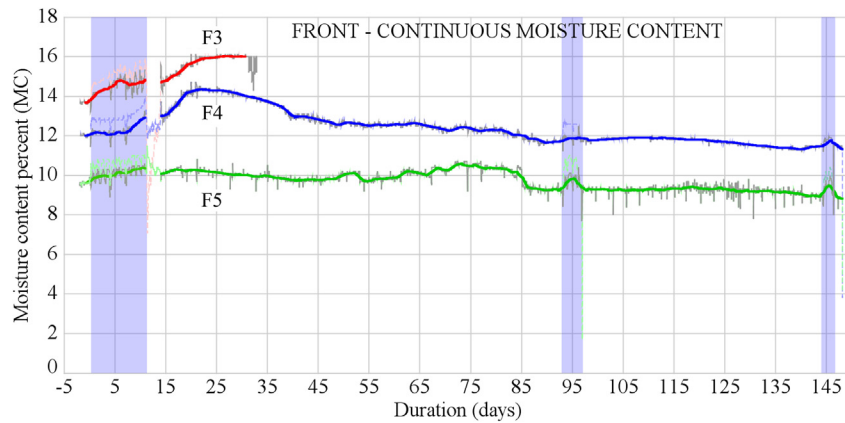
Fig. 8. Continuous moisture measurements at the front location. The thick lines are 48-h moving averages. The thinner lines are original data. The shaded areas are wetting periods.

Figs. 8–10 show plots of continuous measurements at the bottom three plies for locations depicted in Fig. 4. Fig. 11 shows post- and pre-wetting MC gradients in the three uppermost layers measured through discontinuous readings with the handheld resistance meter. The discontinuous measurements are averages of readings in the front, mid, and rear regions (Fig. 5), respectively. The data refer to the last two wetting events and the last drying event. The complete series of measurements is available in the appendix. Continuous measurements showed relatively small MC increases (+2% MC or less), while discontinuous measurements showed higher MC gains. The discontinuous measurements also highlighted the tendency for moisture to concentrate at the interface of the two uppermost plies following wetting events, rather than at just the uppermost surface. A recent study by Morrell et al. [38], which used CAT scans to observe MC concentrations in exposed CLT, also displayed this tendency. The mid location (at the half-lap joint) showed higher MC concentrations at each of its measured interfaces after wetting. While all of the interfaces also showed rapid

Continuous measurements at R4 and R5 (Fig. 10) displayed a general trend of moisture content decrease (approximately 1.5% MC loss over the entire measurement period), during drying. R4 lost moisture at similar rates as R5, indicating that the gaps in the bottom surface ply may have facilitated more rapid drying at the second layer, similar to how discontinuous measurements showed that areas near gaps appeared to wet as well as dry faster. F5 showed only small changes in MC, despite similar conditions to F3 and F4 (the two plies directly above), which showed MC increases of circa 2% (Fig. 8). Moisture may

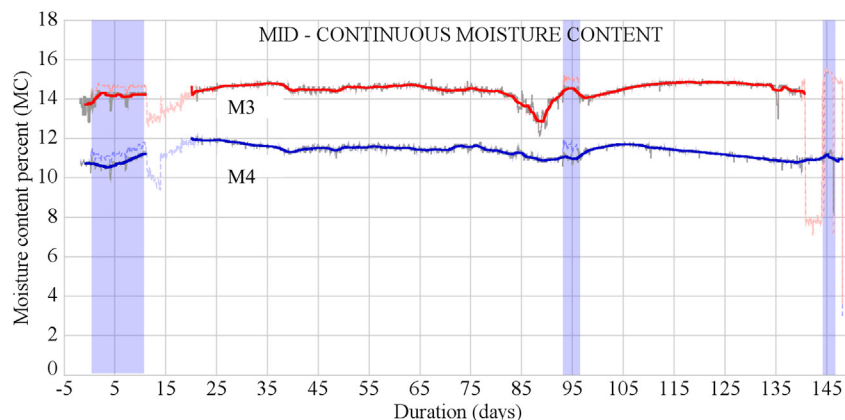
Fig. 9. Continuous moisture measurements at the mid location. The thick lines are 48-h moving averages. The thinner lines are original data. The shaded areas are wetting periods.

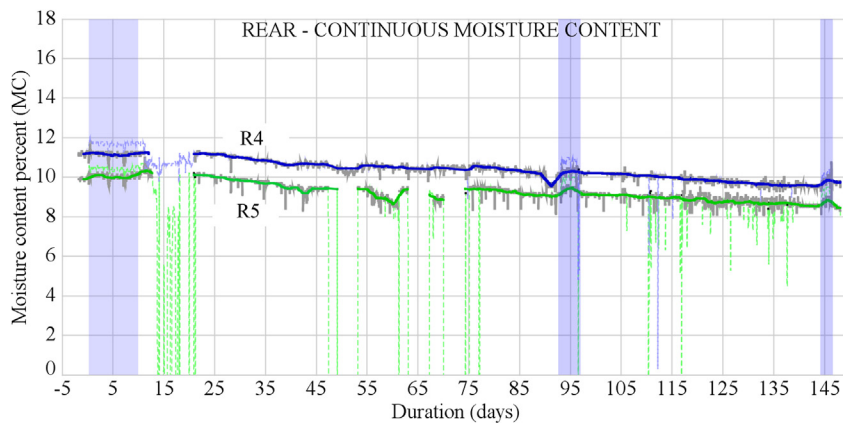
Fig. 10. Continuous moisture measurements at the rear location. The thick lines are 48-h moving averages. The thinner lines are original data. The shaded areas are wetting periods.

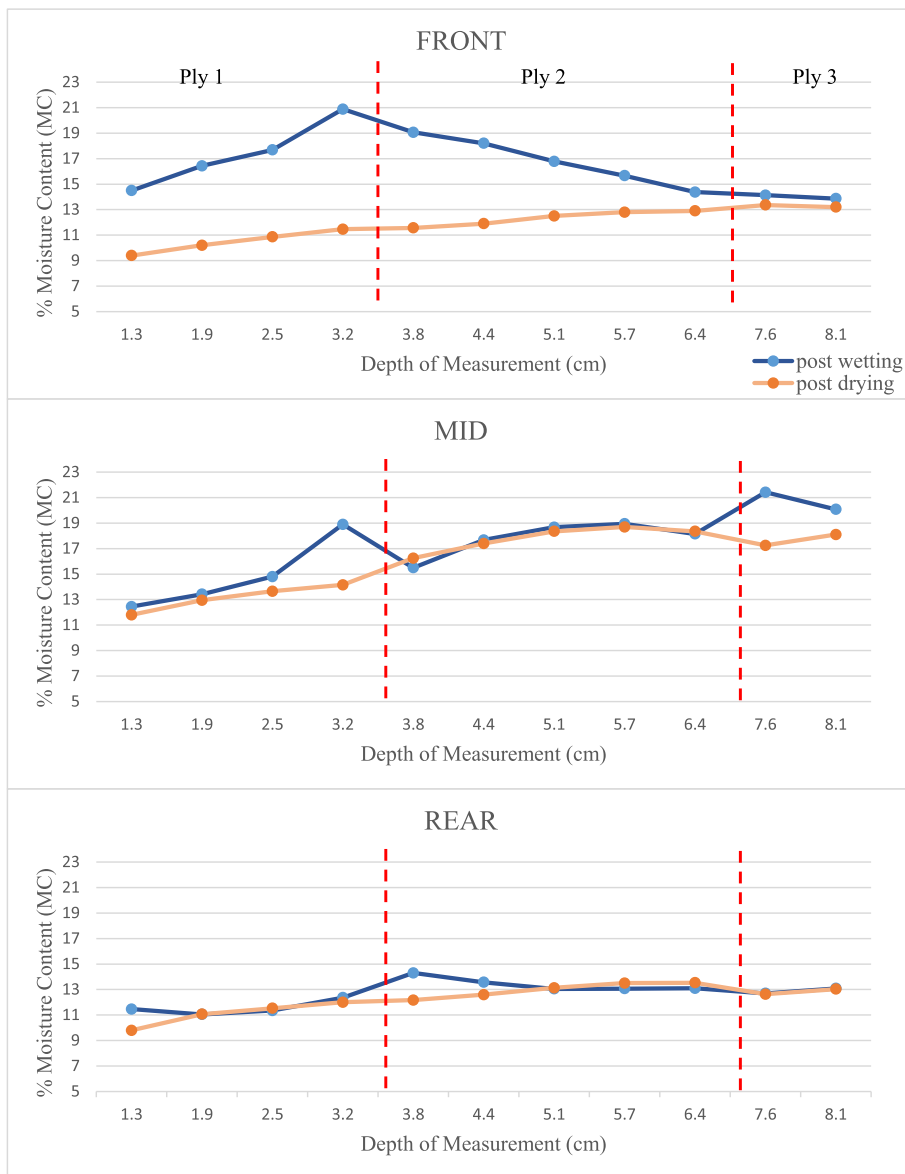
Fig. 11. Average values of proximate, discontinuous moisture measurements in the three uppermost plies at the front, mid and rear location, after wetting and after drying.

Discontinuous measurements 15 cm away from the half-lap connection (Fig. 11 “MID” and Table 4 in the appendix) showed high moisture gain and retention in the 2nd and 3rd plies, even during extended drying (130 days of cumulative drying, with just 14 days of cumulative wetting). Continuous measurements at the mid location (M-3 and M-4), about 30 cm away from the half-lap, did not show this trend as clearly, although they showed slightly lower drying ability than the front and rear locations. Moisture levels observed near the half-lap could reasonably account for the higher global panel mass observed after drying. Moisture retention was anticipated at this joint, since the presence of channels with little air flow are prone to moisture trapping and are particularly vulnerable when coupled with unsealed end grain [3,25]. Since moisture appeared to fluctuate and/or accrue primarily at edges, gaps, and connection conditions, it follows that these locations present the greatest concerns regarding moisture ingress and its affiliated issues (e.g., checking, dimensional stability, etc.). This risk is critical since connections play a primary role in defining the stiffness and dynamic characteristics of timber structures [39].

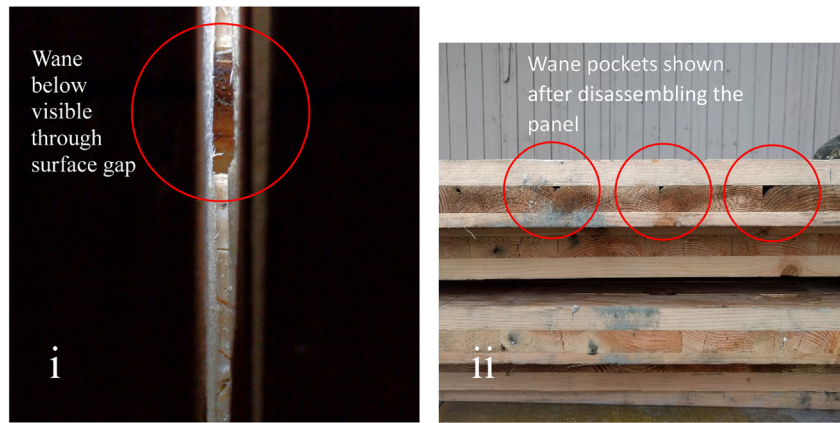
Fig. 12. Wane in the CLT panel. (i) — Wane clearly visibly through surface gap. Note cracks in resin. (ii) — Wane visible in the second ply after disassembly of the half-lap joint.

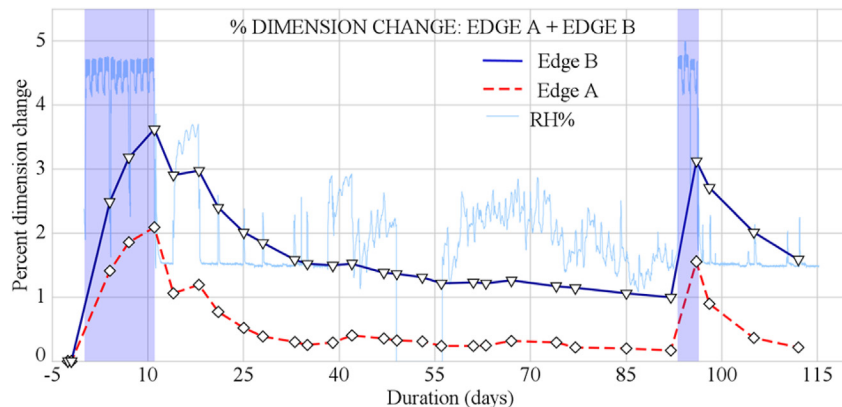
Fig. 13. Percent dimension change in the thickness of the panel at its edges A and B.

The effects of physical deterioration were observable in thickness measurements (Fig. 13), which indicated a displacement from original dimensions with cycling. Edge “B” showed greater displacement than “A”, as well as greater levels cycling-induced damage. Interfacial shearing was pronounced at the gaps between boards at the interface of the exterior plies (1 → 2; 4 → 5), where large MC fluctuations resulted in cupping (Figs. 14 and 15).

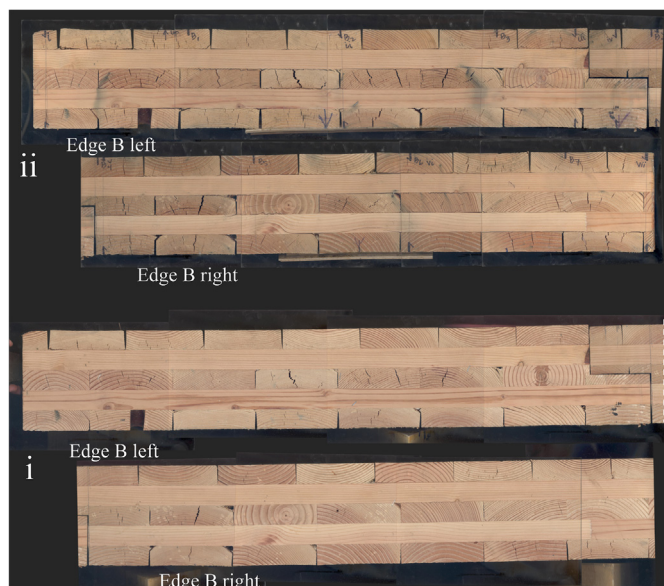
Fig. 14. Edge B before and after weathering. (ii): Edge B after two cycles of weathering. (i): edge B before weathering.

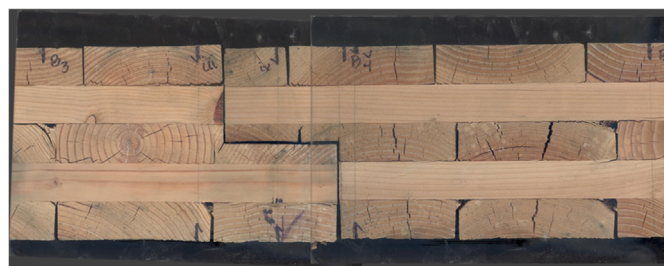
Fig. 15. Checking, cupping, and general deterioration of the panel observed in edge B near the half-lap joint after weathering.
