Remote moisture monitoring of timber bridges: a case study

ABSTRACT: This paper reports on the remote moisture monitoring of a timber traffic bridge in Switzerland. Timber has been a structural material for bridges for centuries, exploiting its high ratio of bending strength to weight. Numerous examples throughout the world demonstrate the durability of timber; if designed and monitored adequately. But timber is biodegradable, and it is recommended for timber bridges that inspections are carried out at regular intervals; until recently, such inspections were carried out exclusively through on-site visits. An automated remote monitoring system provides a more efficient way to enable a sound structural assessment with continuous records of almost any required parameter. This is of special interest to owners of bridges, who must ensure the ongoing safety of their structures. In the case study, a concept to experimentally gather relevant moisture data was developed, at different locations of the structure as well as different depths inside individual members; additionally, climate variables are recorded and related to the moisture content measurements. A data recording system was inst

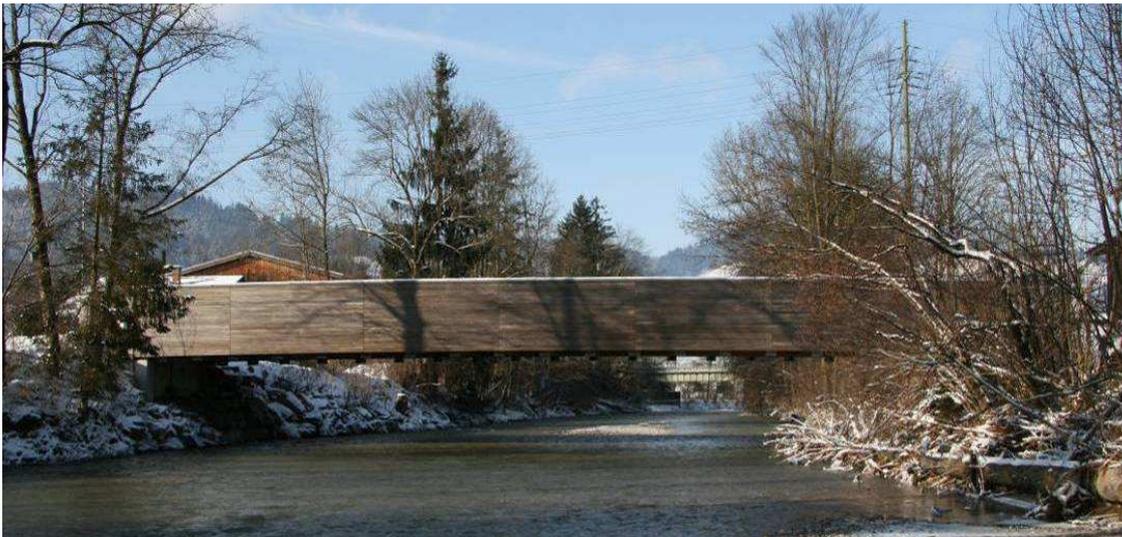
Figure 1. Timber traffic bridge in Obermatt

The construction of the bridge in Obermatt was one project within the renovation of four timber bridges in the famous Swiss Emmental valley. Floods in the summer of 2005 partly damaged the bridge and showed that the original free board height of 0.9m did not provide sufficient protection against a possible blockage. The responsible engineers (Paul Grunder and Raymond Weinmann) therefore incorporated a hydraulic lifting system at the abutments, this way, at flood risk the bridge can be hydraulically raised by 0.7m. The bridge, illustrated in Figure 1, was designed according to Swiss Standard SIA 261:2003 for a traffic load of 40tons, it contains two longitudinal main beams of glued-laminated timber (GL24 according to EC5); the load from the deck is transferred by a series of secondary glue-lam beams. The average daily traffic on the bridge is 2400 vehicles with a 12% proportion of heavy traffic. At present, the allowable traffic velocity is 40km/h, which is planned to be increased to 50km/h.

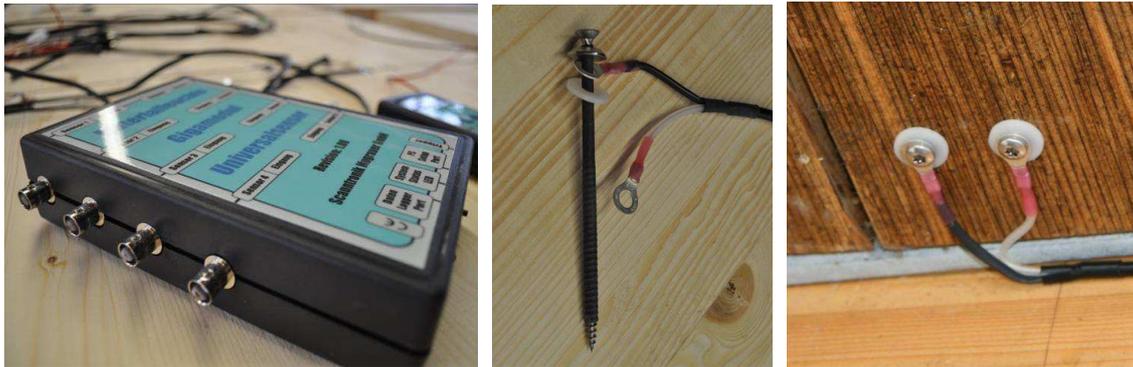
Figure 2. Measurement equipment: Gigamodul© (left), electrode (middle) and installed (right)

It was decided to use the commercially available MC measurement system “Gigamodul”© by Scantronik© (Figure 2 left) together with self-made electrodes consisting of chrome-steel

screws with insulated shanks (Figure 2 middle) which were then driven into the wood with a 32mm distance between them (Figure 2 right). The MC in the support structure and the deck, in particular at the interface between slab and base, are being measured and recorded. A total of 16 measuring points was selected; to investigate the influences of the position in the structure and the depth inside the beam (surface and 200mm depths). The approximate positions and the corresponding labeling are illustrated in Figure 3.
