MONITORING MOVEMENT AT MAKLI

KEY WORDS: Makli Hills, Thatta, Sindh, crack monitoring, subsurface settlement

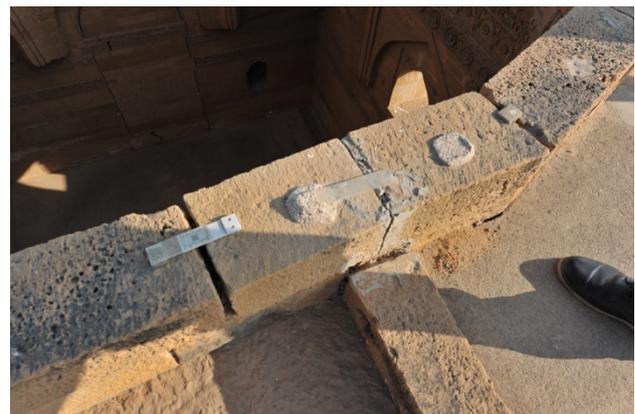
Figure 2. Old plaster and glass crack monitors were discovered on several monuments, but there were no written records

These five monuments were determined to have some historic movement and were of medium to high significance. Plaster or glass crack monitors had been installed in the past, and this also provided an indication that that demonstrated some movement had occurred. These plastic crack monitors cost between 20-30 euros each plus time for installation thus were only used at the more significant monuments. The design of this protocol is that initially, the crack monitors were to be inspected bi-weekly by observation, digital calipers, and photography. This would be entered into a log book. Should no movement be detected, then the inspection would be reduced to once per month. Should any movement be detected, the frequency of inspection would increase, additional crack monitors installed and more accurate digital crack monitors will be considered. These crack monitors were installed with UV resistant silicon which with solvent could be easily removed. Screws and epoxy were not used in the original masonry unless deemed absolutely necessary.

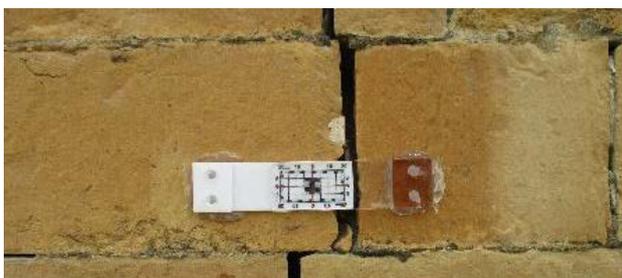
Figure 3. Installation of polycarbonate crack monitors

For the more significant monuments at a higher risk level and closer to the head of the slope, polycarbonate two-piece crack monitors (Avanguard type) with an accuracy of 0.3 millimeters were installed in various critical specific locations both perpendicular and parallel to the slope. These were installed at five major monuments in January 2017 by the Department of Antiquities. Fifteen crack monitors were installed at five significant monuments at Makli including the mausoleums of Jam Nizamuddin, Deewan Shurfa Khan, Issa Khan Tarkahn-II, Mirza Jani Baig and Tughral Baig.

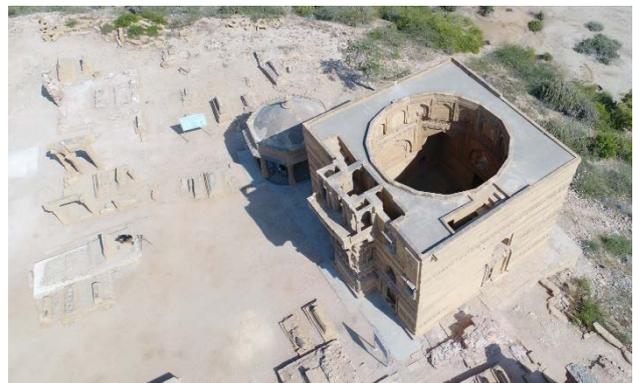
Figure 5. The highly significant tomb of Jam Nizam Al Din at the north end of the Makli Hills, World Heritage property

At the highly significant tomb of Jam Nizam Al Din, a more precise method of monitoring movement was required. This tomb is at high risk at the very head of the slope, and various structural intervention attempts were made over the last century to halt movement. These past interventions included a massive concrete slab between the monument and the head of the slope, large masonry infills within the lower historic openings, grouting, and filling of large 20-30 cracks in the mortar joints. It was known from the archival photographs and research that many of these interventions and the historic openings had been closed in the early XXth century during the British Period. In addition, limited crack monitoring had taken place with glass tell-tales and plaster monitors. However, this monitoring was insufficiently documented, undated, and several monitors were broken. Twelve plastic crack monitors were installed as per the previously mentioned process, both parallel and perpendicular to the slope in both the vertical and horizontal directions. One of the monitors installed during the initial phase of this process showed a movement of 1.0 mm.

To enhance the monitoring of the movement, a highly sensitive digital crack monitor (Rissfox Datenlogger Scantronik Magrauer with Softfox) was installed. This crack monitor is sensitive to 0.0026 mm, and during a test installation, it was observed that the monument expanded and contracted by over 0.4mm due to daily temperature changes. Due to the high cost of this method, only one monitor was installed at the point of highest bending moment at the roof masonry at the furthest point from the foundations. Also, due to the high cost, only one digital crack monitor was installed. Should any movement be detected, additional digital crack monitors can be installed and networked together along with temperature and humidity sensors. Training in installation and operation of this digital crack monitor was included in this process as well as a continued monitoring protocol and use of the software. One important aspect of this installation was real-time monitoring. Should interventions take place on or near the monument, such as the drilling of additional exploratory geological boreholes, or intervention such as micro-pilings or other conservation measures, the on-site conservation team are able to monitor any movement in real-time and be able to stop all work once a certain tolerance of movement has been detected. Other highly sensitive instruments for monitoring movement were considered such as a vibrating wire crack monitor but these were prohibitively expensive, and the accuracy of the selected instrument was deemed adequate.

The final category of more accurate monitoring at Jam Nizam Al Din has, over the ten months of monitoring revealed no significant structural movements. The main north-south crack that is parallel to the head of the slope expands and contracts daily with temperature fluctuations of between 0,061+mm and 0,042- mm. Nevertheless, the team is monitoring the situation on a monthly basis and continues to study the data. Should an earthquake, heavy rain, or monsoon occur, the team will immediately check the data. This process has resulted in a better knowledge of the movement and nature of the structure and prepares the site management for a more in-depth study in preparation for intervention.

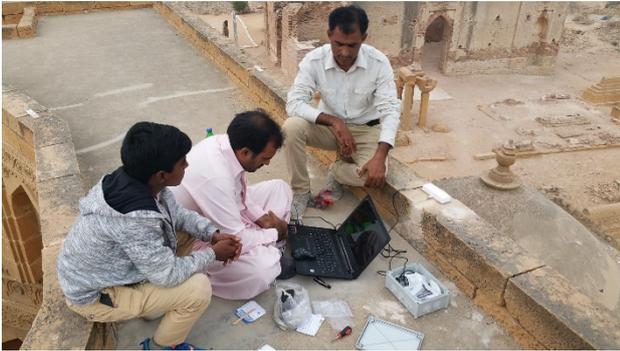
Figure 6. The team installing the digital crack monitor, 2019

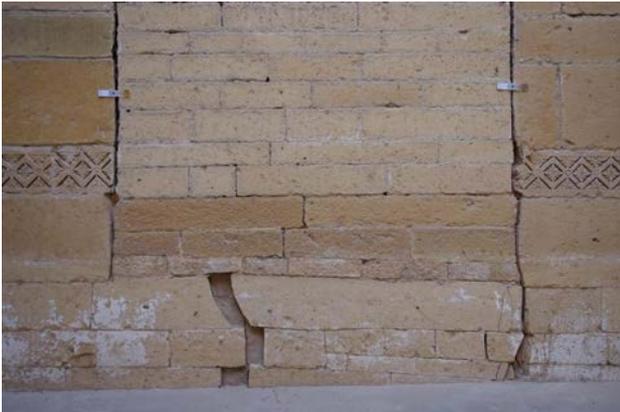
Figure 7. large cracks between the masonry infill and the original structure, 2018

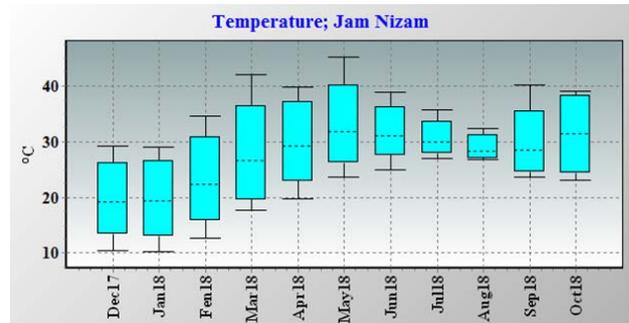
Figure 8. Box plot for the temperature of Jam Nizam site

One important aspect of monitoring the movement at the tomb of Jam Nizam Al Din with highly accurate instrumentation is the correlation of the crack monitoring data with temperature. This is necessary to determine if the movement is due to temperature changes. Fortunately, the site management installed a meteorological station very close to the tomb. In 2018, a meteorological report was conducted by Nadeem Faisal & Asif Hussain, PMD. The data for the period 10th November 2017 to 12 November 2018 was assessed, and the monitoring is ongoing. The data at Jam Nizam site was processed, and a box plot for extreme and average temperature for the site is depicted below. The bottom whisker indicates the lowest temperature while an upper whisker indicates the highest maximum temperatures of each month. The upper & bottom parts of the boxes are representing the average maximum, and minimum values and small size of black dotted lines in boxes are the average temperature values of each month (Faisal, 2018). This data is being correlated with the crack monitoring data. An integrated temperature system inside the crack monitor was investigated but deemed unnecessary as the weather had already been installed nearby and was functioning adequately.

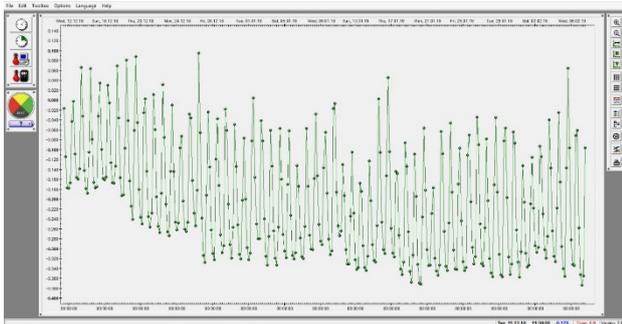
Figure 9. Digital crack monitor results showing the daily movement of 0,061+mm and 0,042- mm due to thermal expansion
