Micro and material climate monitoring in wooden buildings in sub-Alpine environments

Davor Kržišnik, Boštjan Lesar, Nejc Thaler, Miha Humar*

University of Ljubljana, Biotechnical Faculty, Jamnikarjeva 101, 1000 Ljubljana, Slovenia

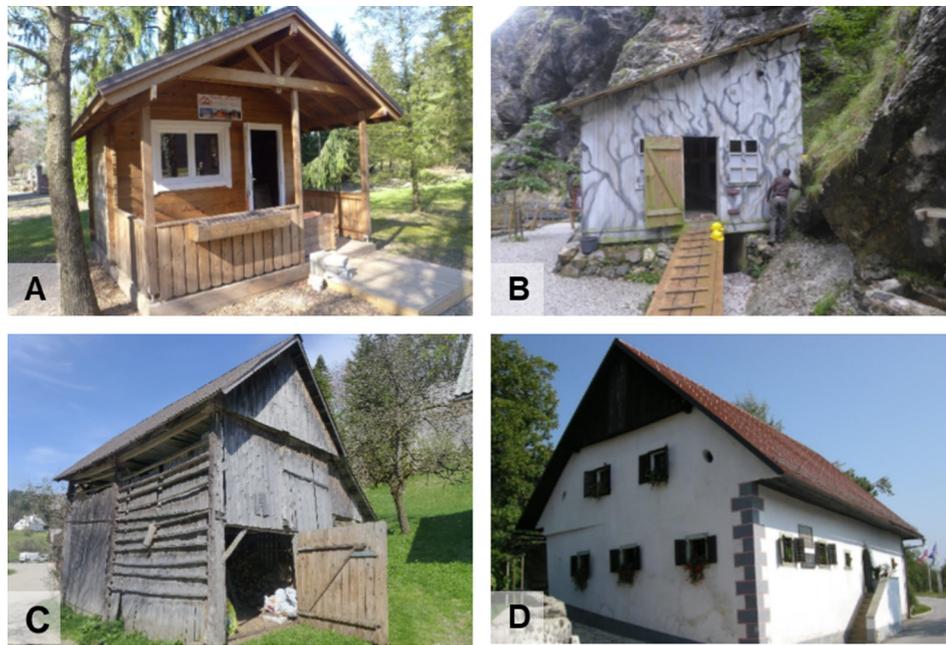
Fig. 1. Model house made of thermally modified wood in Mozirje (A), WWII partisan hospital Franja (B), hayrack on Pokljuka (C), and house in the north of Slovenia in Vrba (D).

Monitoring was performed on four objects located in different locations with distinctive micro-climates (Fig. 1): a model house made of thermally modified wood in Mozirje (1), WWII partisan hospital Franja (2), a hayrack in Pokljuka (3), and a house in the north of Slovenia in Vrba (4). In Vrba, measurements were performed at two locations: cellar and attic. All of the objects are fairly close together from a geographical perspective. The longest distance between them is less than 100 km.

The model house in Mozirje (N 46.334802, E 14.961115) is a log house made of thermally modified (TM) 8 cm thick prefabricated spruce logs (*Picea abies*) (Fig. 1A). The house was constructed in 2009 for exhibition purposes by the company LogHouse (Nazarje, Slovenia). The logs are made of thermally modified wood according to the Silvapro® procedure (Silvaprodukt, Slovenia) at a T around 230 °C. The logs are not surface coated. The dimensions of the cabin are approximately 2 m × 3 m. The cabin is located in a park close to the river Savinja, approximately 340 m above sea level.

Some minor parts of the cabin are made of untreated wood, which enabled a comparison between thermally modified wood and reference Norway spruce (*Picea abies*) (Table 1). The second object is a “cabin for the wounded” at the Franja partisan hospital (<http://www.muzej-idrija-cerkno.si>) (Fig. 1B). This hospital is situated in a remote location in Pasice gorge near Cerkno (N 46.154081, E 14.028197), approximately 600 m above sea level. Since the stream in the gorge is present in all seasons, the RH is always very high. The majority of the huts were completely renovated in 2010 after a disastrous flood in September 2007. The design of the hospital is the same as it was during WWII. It should be noted that the huts were designed as temporary shelters, and subsequently declared a cultural monument of national importance. All the huts are made primarily of Norway spruce wood (*P. abies*). Since the climatic conditions in the gorge are fairly harsh, all the Norway spruce wood was dip-treated with copper-ethanolamine based wood preservative (Cu-EA) (Silvanolin®, Silvaprodukt). The impregnation procedure was not performed correctly, so considerable decay has taken place in the most exposed wood.

The third object, a hayrack on Pokljuka (N 46.304674, E 13.984277), was built approximately 100 years ago and was used in the past for drying and storing hay and other agricultural products (Fig. 1C). The hayrack is made of larch (*Larix decidua*) and Norway spruce (*P. abies*). It is located approximately 1000 m above sea level on an alpine plateau. The last, fourth monitoring was performed in an old farmhouse in the village of Vrba (N 46.387899, E 14.147478) (Fig. 1D). The house has been declared a cultural monument, as an example of old architecture and because it was the birthplace of the Slovenian poet, France Prešeren. The house is located in a sunny exposure, approximately 500 m above sea level (Fig. 1D). In Vrba, measurements were performed in the cellar (humid, not hydro-insulated cellar) and in the attic (dry, ventilated conditions). Use classes of the wood were determined according to EN 335 [25]. All buildings were unheated.
